RESTAURATION OF THE PONT TRENCAT (BROKEN BRIDGE)

Xavier Font

MLM Consulting Engineers (former Alfa Polaris, S.L.)

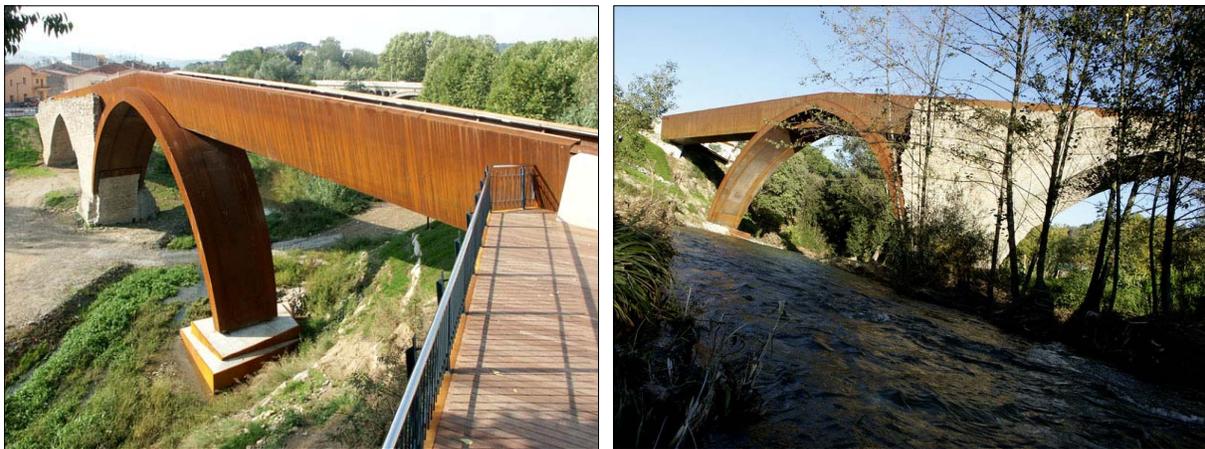
Figure 1 – General views of the bridge

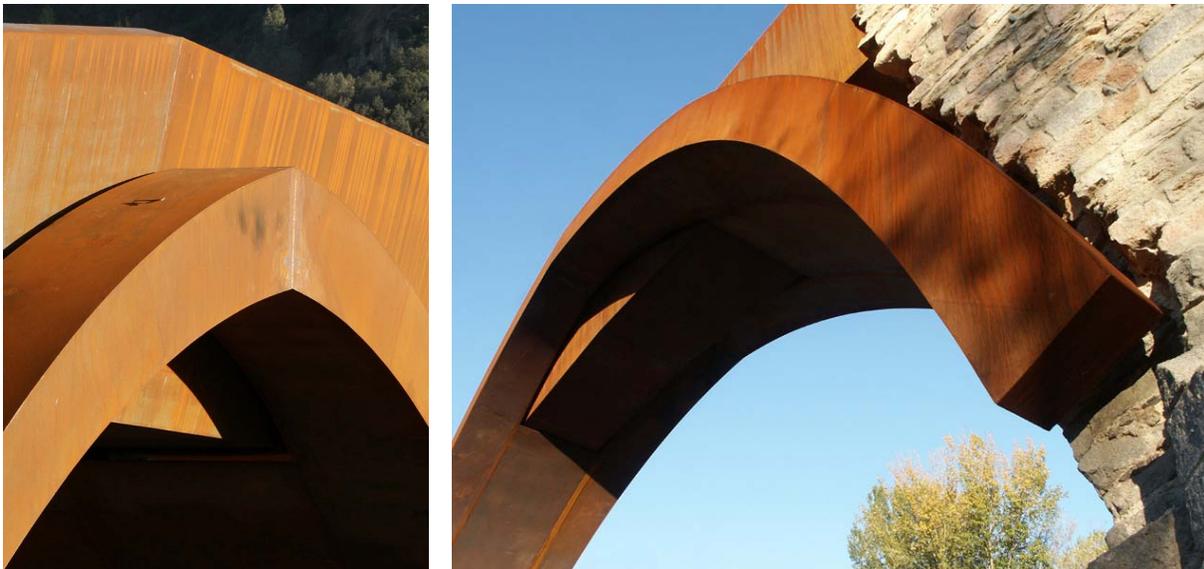
Figure 1 - Some details of the arch

The works were divided into three phases. In the first one we consolidated and repaired the existing remains trying to follow a non-interventional attitude. We avoided anything that could change its traditional appearance and, when it wasn't possible, for instance when we reinforced the bottom of the lateral walls because of some underminings, we underlined our intervention using a completely different material, in our case, concrete. We also carried out the new foundation of the arch, on the right bank. In the second phase the abutments of the deck were made; one on the existing remains, and the other one on the left bank. The steel structure was constructed seventy kilometres away from the work side, and transported in five pieces; three for the deck and two for the arch. We first lifted the two parts of the arch which were welded to each other in the crown. For the deck, before it was erected, we welded two of its parts and then we installed it in two pieces welded to each other on site. In the third phase the pavement was made. Over the bridge we choose a timber pavement in order to provide pedestrians a warmer and more tactile material in contrast with the coldness of the steel. On both approaches the pavement was a combination made of rosé granite stone and washed concrete pieces. The street lighting over the bridge was placed into the parapets of the deck. On the ends, on each side, we installed some modern lampposts. The monumental lighting was placed on the lateral slopes, over the maximum flood level.
