Analysis of the Florida International University Pedestrian Bridge Collapse

Vojtěch Kolínský, Jan Žitný

FINLEY Engineering Group International, Prague, Czechia

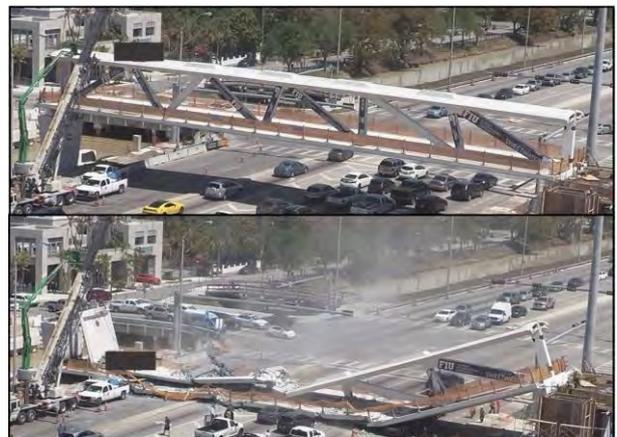
On Thursday, March 15, 2018, a partially constructed pedestrian bridge crossing an eight-lane roadway in Miami, Florida, experienced a catastrophic structural failure in the nodal connection between truss members and the bridge deck. The 174-foot-long bridge span fell about 18.5 feet onto SW 8th Street, see Figure 1. Eight vehicles located below the bridge were fully or partially crushed. One bridge worker and five vehicle occupants died, another ten people were injured [1].

Figure 1. Prior and after collapse [1]
