## Assessment of structural Condition of an existing Railway Viaduct after excessive Deformations due to nearby tunnelling Works

In the city of Delft, the existing two track railway viaduct will be replaced by a four track railway tunnel. In the central part of the project, where the preferred solution using diaphragm walls as tunnel walls in a top down building sequence was altered into a traditional cut and cover building pit with sheet pile walls; this due to the estimated risk of historic remains in the subsoil. The installation of these sheet pile walls and grout anchor piles induced considerable deformations of a part of the existing railway viaduct. After a first assessment of the viaduct and its foundation, local strengthening of the viaduct piers and slabs was performed. During this period, railway traffic could continue at reduced speed.

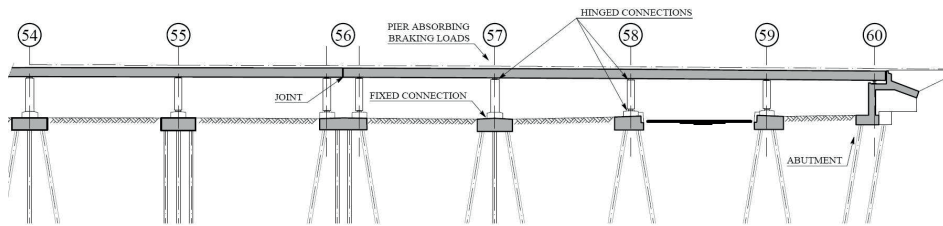
The viaduct consists of a series of posttensioned cast in situ hyperstatic concrete slabs of approximately 50 metres of length. These slabs cover 4 spans of 12 to 13 metres. Each pier has two columns, articulated at both ends of the column, thus forming a perfectly hinged support. As the first slab was situated alongside the Bolwerk building pit, while the second slab was parallel to the diaphragm wall part, both slabs behaved otherwise, thus resulting in unallowable curvature of the rails and the formation of gaps

between columns and slabs.

Fig. 2 : Elevation and structural system of the viaduct

To ensure the equal partition of the mobile loads into both rotated columns, small steel strips were inserted in between upper and lower half of the supports showing gaps and external splitting reinforcement by means of threaded bars and steel profiles were installed. As serious doubts grew about the geotechnical stability of the pier when the speed of the passing trains should rise again, it was decided to create an extra bearing capacity by using the adjacent sheet pile wall as an extra pile. Through the formation of the gaps, the steel dowels at the supports had to cope with an unforeseen bending moment. Conservative design approaches resulted in plastified dowels, thus unable to resist future higher horizontal forces due to increasing train speed. Therefore a bypass structure was implemented.

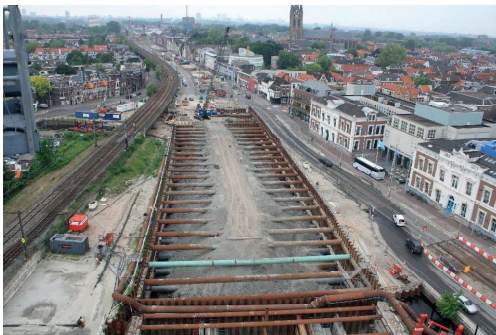
Fig. 3 : Adapted excavation process

Every pier was equipped with a steel strut between the footing and the upper strutting frame of the nearby building pit. Hydraulic jacks could easily be inserted in order to push back the footing that displaced too much. A well defined excavation sequence made it possible to introduce the pre-stress force in the lower strutting frame of the building pit before most of the excavation took place.
