Collapse of the roof of a football stadium

In the summer of 2011 the Dutch football club FC Twente was building an extension of their stadium De Grolsch Veste, to increase the capacity of the stadium. On July 7th 2011, during construction, the roof of the partially finished extension collapsed. As a result of this accident two workers were killed and nine were injured, a few of them critically.

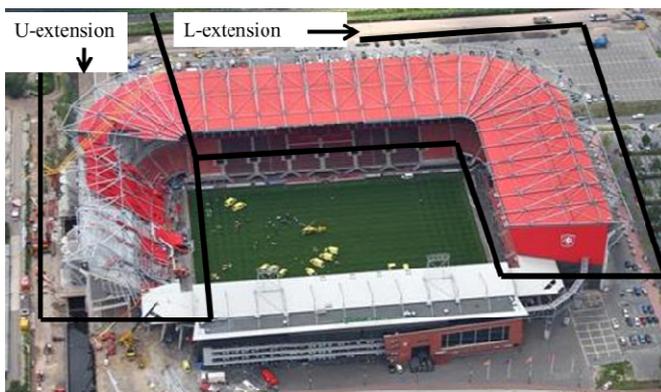
Fig. 1: Overview of the stadium
