## The Instrumentation and monitoring of the Vårby Bridge

### Summary

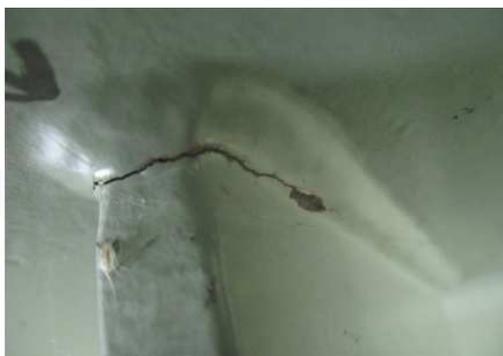
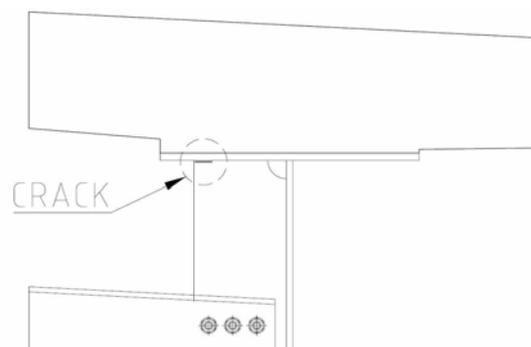
In the summer of 2006 during a routine inspection of the Vårby bridge, numerous cracks were found [1]. Generally, all the cracks occurred at the junctions between cross girders and the main girders, specifically at the welds connecting the vertical web stiffeners to the top flanges of the main girders. All the cracks were located in the spans of the bridge, i.e. at cross girders with a single one side vertical main girder web stiffener, and none were observed at the supports (where the web of the main girders is fitted on both sides with stiffeners).

*Fig. 1: One of the observed cracks*
