## Investigation of fastening failure in tram track structure on a bridge over the Vistula River

### Summary

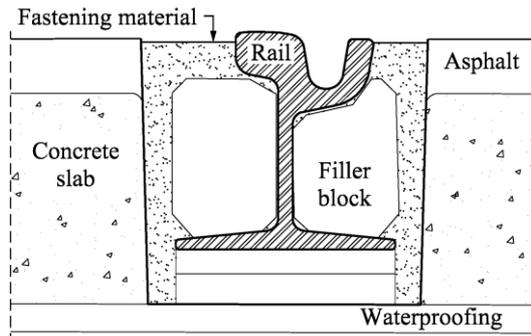
Fig. 2: Cross section of the rail system

with rails poured in-situ was developed (Fig. 2). Polyurethane resin was used as a structural adhesive that forms chemical bonds between the adherent surfaces. Shortly after completion of the work the first damage to the fastening material appeared, as the poured upper part of the fastening material detached from the surfaces of the adherents. The bond durability appeared to be very low and resulted in the splitting and loosening of the upper fastening parts. After losing its bond, the fastening material deformed, twisted and settled down. The damage quickly increased to cover the total length of the track structure on the bridge.

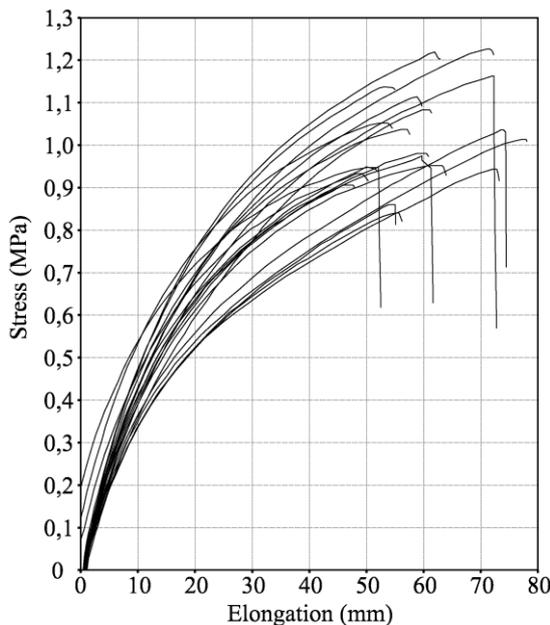
Fig. 3: Stains – stress curves

The first initial visit was on a rainy day, so the insufficient subsurfacing drainage system could be seen immediately. Samples of loose embedding material were taken from the track structure to assess the composition and mechanical properties of the fastening material. The material was tested in tension, compression and tear. Hardness was also measured. Additionally, the composition of the fastening material was verified by Dynamic-Mechanical-Thermal Analysis (DMA) at temperature range from  $-120^{\circ}\text{C}$  to  $+100^{\circ}\text{C}$ . The average values of the tensile properties are: tensile strength 0,92 MPa, tensile modulus 5,34 MPa and elongation at break 57,9% (Fig. 3).
