Investigations on a degraded suspension bridge: damage characterization and rehabilitation

This paper describes the experimental investigations and the planned rehabilitation programme of Teil Bridge in France. Soon after the sudden rupture of a cable near the anchorage, the bridge was closed to traffic. Inspections were carried out to understand the sources of this event and to assess the performance of cables and strand sockets. Prior to rehabilitation, the bridge safety was improved by strengthening each socket; the bridge was then re-opened to pedestrians and cyclists only. An acoustic emission system was installed during a full year period; events related to cable ruptures were accordingly monitored. Meanwhile, several other experimental investigations on steel and concrete materials (resilience, tensile steel strength, carbonation and chloride ingresses) were led to estimate the residual structural service life of the bridge and to plan repair actions. A major rehabilitation program was then scheduled with the change of all cables and sockets. This paper presents the different stages of these investigations and the rehabilitation process.

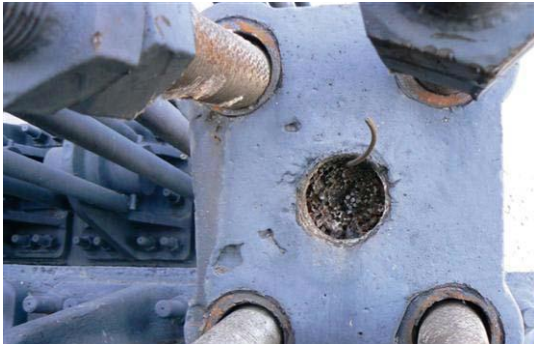
On the morning of September 11th, 2007, the rupture of a cable was detected on the upstream right bank, roughly 4 cm inside the cable socket (Fig.2). The analysis of the wires in the broken area

confirmed the presence of corrosion due to the deficiency of the socket sealing (defective zinc filling). The rupture was not subsequent to an overloading event.

Fig. 2: Broken cable

The bridge was immediately closed until to get appropriate safety decisions. The socket where the rupture occurred (No. 5, upstream right bank) was inspected to analyze the fracture surface. It comes that pitting corrosion is present over the full length that is not protected by painting.

From these results, it was decided to re-open the bridge to pedestrians and cyclists only, re-opening to vehicles being postponed after strengthening. Re-opening was conditioned by the installation of a health monitoring system on the bridge. An acoustic emission system and anti-whipping devices were therefore installed on the bridge to prevent any rupture. In addition, an anti-whipping device was installed on the cables close to the anchors. It is composed of steel components that connect four cables together. This device has for purpose to avoid any cable whip that may cause injuries to pedestrians or vehicles on the underneath road. In the same time, sockets were reinforced by jaws that help to redistribute loading over the full socket block.

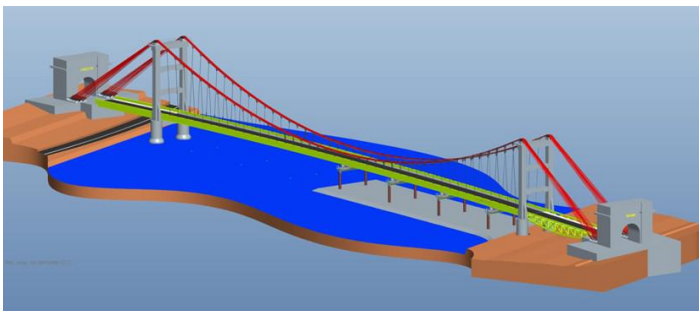
Fig. 10: General view of the bridge and temporary supports

Several options were analysed for the rehabilitation or the replacement of the Teil bridge. It was decided to replace the suspension cable by adding temporary supports. The construction of temporary supports has required the use of a dike par half-span in order to maintain an appropriate waterway. Each dike has facilitated the construction of a working platform for installing the piles, the crossheads and the stiffening trusses. The load sharing between the crossheads and the stiffening trusses is done by a load distribution beam that authorizes the load

transfer compatible with the allowable stresses in the riveted structure. This induced to strengthen the webs to avoid any buckling. The disassembling operation for cables has firstly consisted in adding cables at the top of the pylons to ensure stability during works stages. The new stranded cables are made of galvanized steel wires. The sockets have been mounted in the factory by mechanical welding with a thick steel plate. The tensions in the new cables were adjusted to get the right geometry of the deck and the suspension cables and identical tensions in the hangers.
