## Refurbishment of the concrete-glass windows of Aachen City Hall

### Summary:

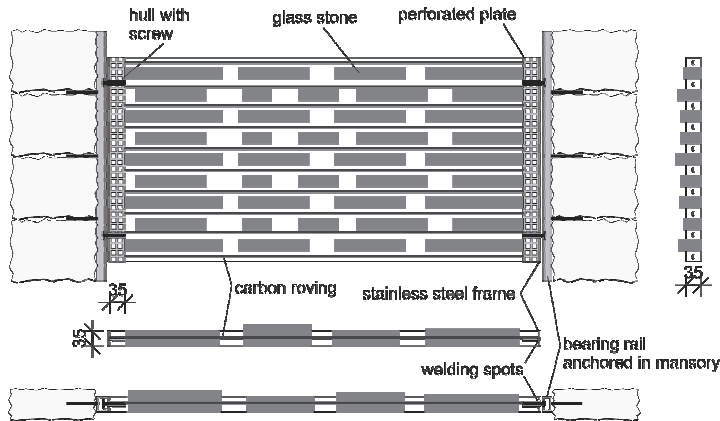
Fig. 2: Sectional view of a concrete-glass window

Fig. 2 shows a sectional view of a window segment. All required components for the production of a concrete-glass window are shown.

Bending tests showed that the glass stones are the decisive component for the structural behaviour in the service state. The glass failed due to compressive stress before cracking occurred in the concrete. Subsequently, the test load was almost doubled to a breaking moment of  $2,5 \text{ kNm/m}$ , which corresponds to a wind load of about  $14 \text{ kN/m}^2$ .

The refurbishment of the historic concrete-glass windows of Aachen City Hall was an extraordinary challenge. The use innovative carbon reinforcement contributed significantly to the solution of the problem. With the use of epoxy-impregnated carbon textiles and a high performance concrete, a corrosion-resistant solution was found.

As textile reinforcement, a scrim of carbon filaments was used. The cross-sectional area of the textile reinforcement mesh is  $110 \text{ mm}^2/\text{m}$ , with  $4,18 \text{ mm}^2$  per roving. To increase the ultimate stress of the roving, the fabric was impregnated with epoxy. By doing so, stresses of more than  $3000 \text{ N/mm}^2$  can be achieved, corresponding to a tensile force of  $12,5 \text{ kN}$  per roving. In addition, the handling and robustness of the reinforcement is increased.

As concrete, a composition with a maximum grain diameter of  $5 \text{ mm}$  was utilized. The concrete has a compressive strength of  $87 \text{ N/mm}^2$  and a bending tensile strength of  $10,6 \text{ N/mm}^2$ . The high material strength is particularly suitable for components that have to remain uncracked in use.

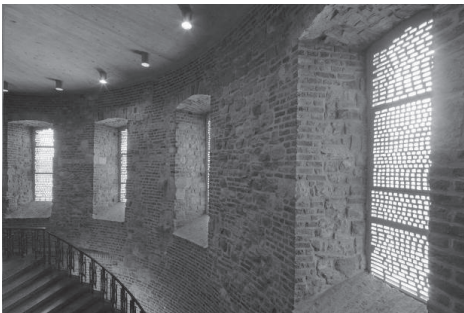
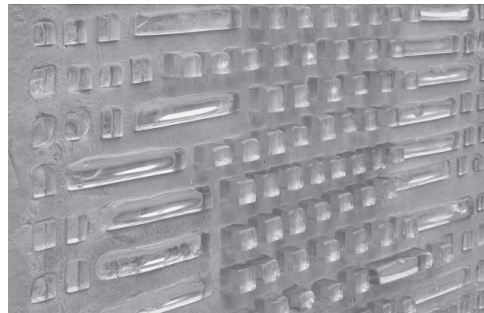
Fig. 3: View of the refurbished windows

In addition, due to high aesthetic quality of the concrete (fig. 3, right), the executed solution (fig. 3, left) also impressed the historic monuments protection authority and critical monument conservators.
