Single span strengthening of a Listed masonry arch railway viaduct

Matt Brimble, Carlos Hernandez Sanchiz

AECOM Mott MacDonald JV, Bristol, UK

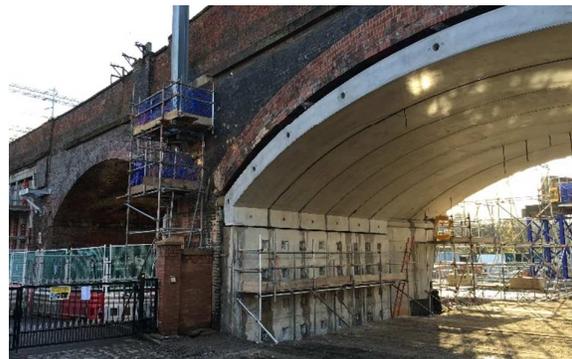
A new arch under-ringing solution has been built beneath the long skew span COL120A of the Castlefield Viaduct, a Grade II Listed brick viaduct which has supported a railway since 1845. Construction of the strengthening was completed in December 2016 – see Figure 1.

Figure 1. COL120A under-ringing, prior to grouting of the arch extrados
