## The structural assessment of the partially collapsed Izbor Viaduct

On Saturday May 6th 2006, the launching of the deck superstructure of the Izbor Viaduct resulted in the partial collapse of the front section of the launched deck. This construction process of launching the deck was aided by a tower and supporting cable-stayed system that was designed to control the deflection of the leading deck section.

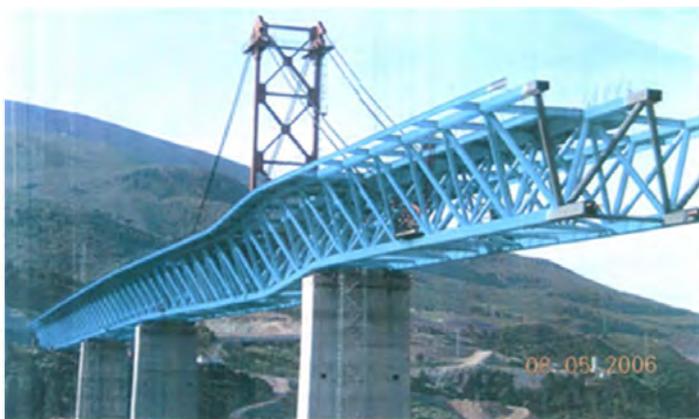
On Saturday May 6th 2006, the launching of the deck superstructure of the Izbor Viaduct resulted in the partial collapse of the front section of the launched deck. The construction process of launching the deck was aided by a tower and supporting cable-stayed system that was designed to control the stresses and deflections experienced by the truss during the erection - see Figure 1.

Figure 1: Partially collapsed Izbor Viaduct
