Fatigue Evaluation and Retrofit of Pearl River Bridge

MDOT commissioned a comprehensive assessment of the I-20/55 Pearl River Bridge in response to cracking in the river crossing spans. Five diaphragm connections were instrumented to evaluate the connection performance under control truck loading before and after the installation of trial retrofits. These retrofits included large cored holes to remove cracks and alter the stresses in the web gap as well as new fillet welds fixing the connection plate to the girder top flange. Test results show that the cracking is caused by out-of-plane distortion of diaphragm connection plates at the girder webs. Attaching the connection plates by welding to the girder top flange and down 305 mm (12 in.) on the web is the recommended retrofit to address both positive and negative moment region cracking and extend the service life of the bridge by more than 30 years.

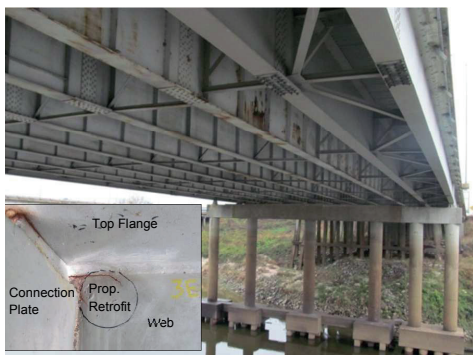
Figure 1 Pearl River Bridge

A comprehensive assessment of the I-20/55 Pearl River Bridge was commissioned by the Mississippi Department of Transportation (MDOT). Work included an instrumentation program to measure live load responses at fatigue sensitive details. This work was in response to cracking in the river crossing spans of both the eastbound and westbound structures (Figure 1).
