Removing Weak Spots from Railway Lines

Summary

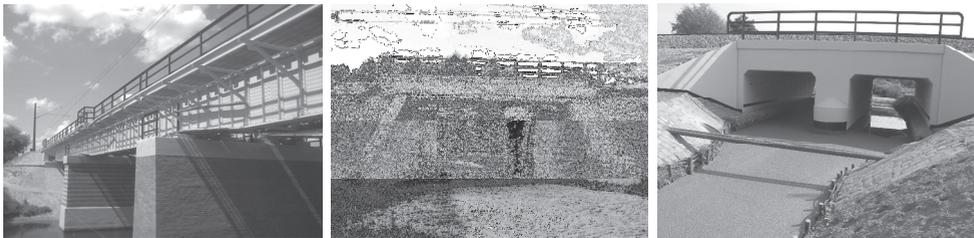
The first bridge designated for strengthening and upgrading is on the Poznań and Skandawa Railway (Fig. 1 left). The bridge has riveted plate girder spans and massive supports. The bridge is located near a town where a chemical plant produces soda for the food-processing and chemical industries. This results in a corrosive environment which influences the steel bridge structure. Replacement of the track structures, bearings and sidewalks was necessary. Strengthening of the steelwork and the replacement of corroded elements were also necessary. Corroded plates of were replaced by new thicker plates in the upper flanges in the four spans. The severely corroded gusset plates and diagonals of the wind bracings were replaced with new ones. Huck lock bolts were used as permanent fasteners. Designs were drawn for the repair of the brickwork supports and rebuilding of the abutments with new reinforced concrete backwalls and wings. New bridge timber sleepers were supported on centring devices. Centring shims on the upper flanges of the plate girders were site welded. A general view of the bridge is presented in Figure 1 (left photo).

Fig. 1: General view of the bridges after rebuilding

The third bridge which was designated for replacement is on the Warsaw and Kunowice Railway. The railway line is part of the E20 international transportation corridor linking West and East (Berlin and Moscow). The bridge was constructed in 1947 and problems with the integrity of the spans arose a few years later because an intermediate support was added. The additional support allowed the survival of the bridge for several decades further but under-maintenance and excessive leakage caused the concrete to disintegrate over the years. The railway agency allowed the bridge to be replaced by a concrete box culvert. The prefabricated structure for the culvert pipes was developed. To avoid using a temporary waybeam structure it was decided to construct the new culvert under the existing bridge whose spans would still be carrying two tracks of the line during the works. A view of the culvert after rebuilding is presented in Figure 1 (right photo).
