Slip in Hanger Cable Anchorages of Dintelhaven Railway Bridge Rotterdam

The Dintelhaven Railway Bridge in Rotterdam, The Netherlands is a stiffened bowstring steel bridge spanning 170 m (Fig. 1). Its hangers are formed by cables consisting of parallel strands attached to the arch and the main girder through 'traditional' anchorages. Shortly after erection of the bridge, a load test was performed before taking the bridge in operation. It turned out that quite a number of strands of the hanger cables slipped through their anchorages. The main cause turned out to be 'sticking together' of the outer wedge surface and the cone shaped hole surface in the anchor plate. This yields a high coefficient of friction between wedges and cone shaped hole surface. Increasing the cable force does not cause the wedges to enter the cone shaped hole any further (as intended), but causes the strands to slip through the wedges. The paper describes these phenomena in detail and gives a practical solution to overcome the problem of slip in cable anchorages.

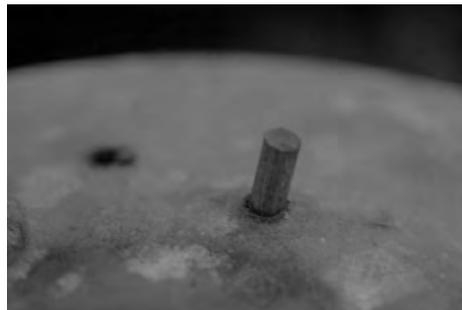
The time period between assembly of the hanger cables resulting in low cable forces and the substantially stressing of the hanger cables by applying the ballasted track was several months. During train load testing, loud bangs and creaking sounds were heard. When removing the measuring equipment, it turned out that several strands of the hanger cables had been 'launched' against the protection caps of the cable anchorages, even perforating some of these caps (Fig.2).

Fig. 2: Damaged anchorage protection cap

Sufficient bite of the wedges on the strands could be achieved by pushing-in the wedges into the cone shaped hole. Pushing-in the wedges was tested in the laboratory of TNO determining the right procedure and showing that there is no detrimental fatigue effect of this procedure.

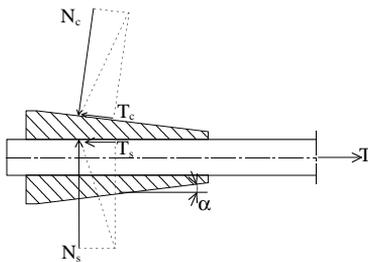
The equilibrium of forces around the wedges (Fig. 3) turned out to be the key to find the main cause of slipping of the strands. It can be shown that slip occurs if:

$$\mu_c > \frac{\mu_s - \tan \alpha}{1 + \mu_s \tan \alpha} \quad (1)$$

Fig. 3: Force equilibrium at wedges

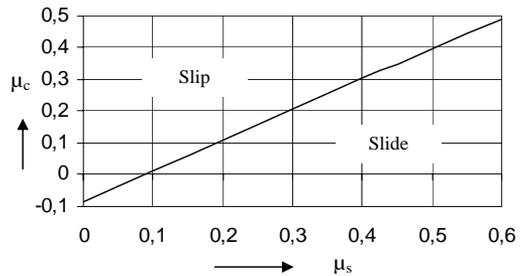
Where μ_c is the coefficient of friction on the cone shaped surface of the anchor plate and μ_s is the coefficient of friction on the strand surface. This is illustrated in Fig.4. For the relatively small

Fig. 4: Slip or slide depends on coefficients of friction

coefficient of friction on the strand surface with $\mu_s = 0.1$ and $\alpha = 5^\circ$ slip already occurs if (Eqn.(1)) $\mu_c > 0.01$. In case the coefficient of friction on the strand surface is relatively small, almost any friction on the cone shaped surface is enough to make the strands slip. Due to the assembly method of the bridge, the coefficient of friction on the strand surface was relatively small.
