The assessment, strengthening and widening of Thames Bray Bridge

David Collings

ARCADIS, London, UK

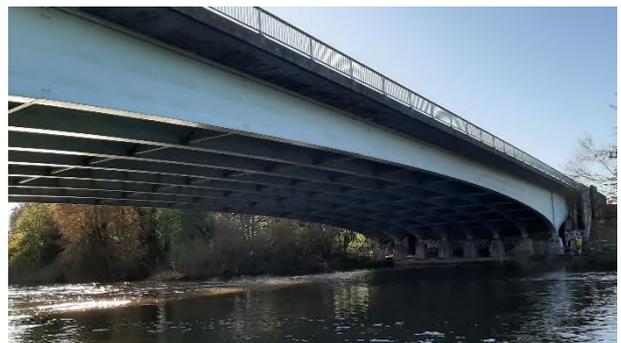
Figure 1. Elevation of Thames Bray Bridge

The bridge is unusual as in addition to the motorway it also carries a footpath over the river connecting the villages of Bray and Dorney. Figure 1 shows the bridge main span over the river, the

short 11m back span is visible with the tiedowns hidden within the abutment (see Figure 2).
