Condition assessment of several bridges in Sofia based on visual inspection and as-built drawings

Alexander Jiponov, Lazar Georgiev

University of Architecture, Civil engineering and Geodesy, Sofia, Bulgaria

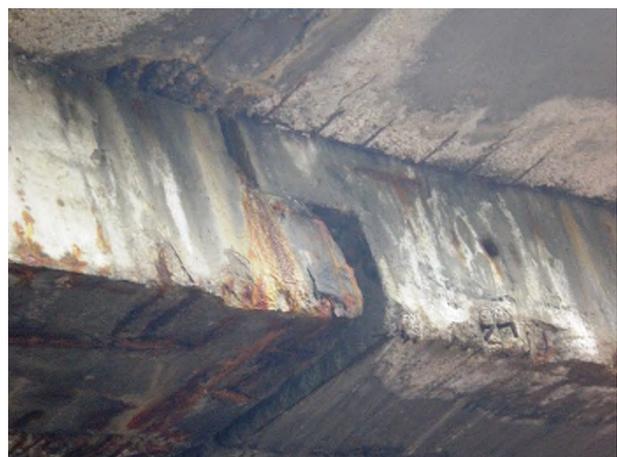
On the other hand it must be mentioned that in particular bridges details with low reliability as for example Gerber joints were widely used in the past [1]. Such critical detail is shown on Figure 1.

Figure 1. Gerber joint of RC bridge in Sofia, 2008

In these cases, the superstructure is statically determinable, but the robustness level of the detail is low and respectively there is high risk of
