## Development of the St Croix River Extradosed Bridge Form

### Summary

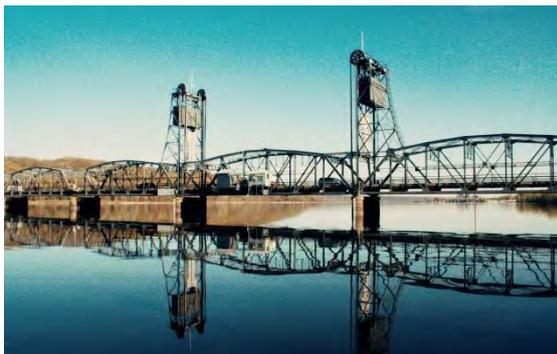
*Fig 1: Existing Stillwater Lift Bridge*

The Stillwater Bridge over the lower St Croix River has been an important link between Minnesota and Wisconsin since it was first opened in 1876. The bridge was originally a timber toll bridge with a pontoon section that could be swung open to let vessels and log rafts past. The original timber bridge was under constant repair until it was replaced in 1931 by the existing steel lift span shown in Fig 1.

The approach roads to the existing bridge on the Wisconsin side of the crossing are steep and unsafe in winter conditions. The structure lacks pedestrian or bicycle access, carries only two lanes of traffic and congestion backs up onto the nearby main streets of Stillwater when the lift span is opened. The bridge also regularly closes when flood water over tops the bridge deck thereby limiting emergency access across the river.
