The Existing Champlain Bridge - Overview of Issues – The Owner's Perspective

The Jacques Cartier & Champlain Bridges Incorporated, Longueuil, QC, CANADA

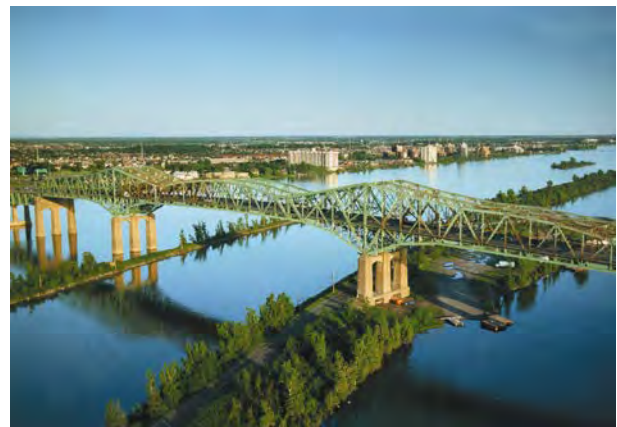
Figure 1. Champlain Bridge Main Span
