Long-term vibration monitoring on railway bridge KW51 in Leuven, Belgium

Kristof Maes, Geert Lombaert

Department of Civil Engineering, KU Leuven, Leuven, Belgium

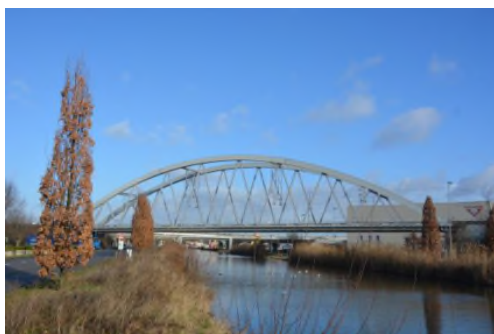
Figure 1. Railway bridge KW51.

Railway bridge KW51, shown in Figure 1, is located on railway line L36N between Leuven and Brussels, Belgium, where it enables the crossing of the canal Leuven-Mechelen. The bridge, of the type bow-string, has a length of 115 m and a width of 12.4 m.

The railway bridge consists of two ballasted tracks, both characterized by a curve radius of about

1120 m. A maximum speed of 160 km/h is imposed. A monitoring system was installed on the bridge in September 2018. The measurement setup, which is briefly recapitulated in Section 2, is described in detail in [1].
