## Recalculation and strengthening of the double arch bridge

Sander van Alphen MSc, Arjen Steenbrink MSc, Anne Blom BSc, Bert Hesselink BSc

Among the Netherlands' present infrastructure, some bridges do not conform to the prevailing Eurocode for new construction; some steel bridges are showing signs of (fatigue) damage. Over recent years, the Directorate-General for Public Works and Water Management (RWS) has been engaged in renovating the most critical bridges of the Netherlands, one bridge at a time. RWS is currently making preparations for the reinforcement of 3 steel bridges along the A27 motorway. Last year, Movares made complete recalculations for these bridges in order to determine what measures are necessary to reinforce them. This paper discusses the Merwede Bridge over the Upper Merwede river.

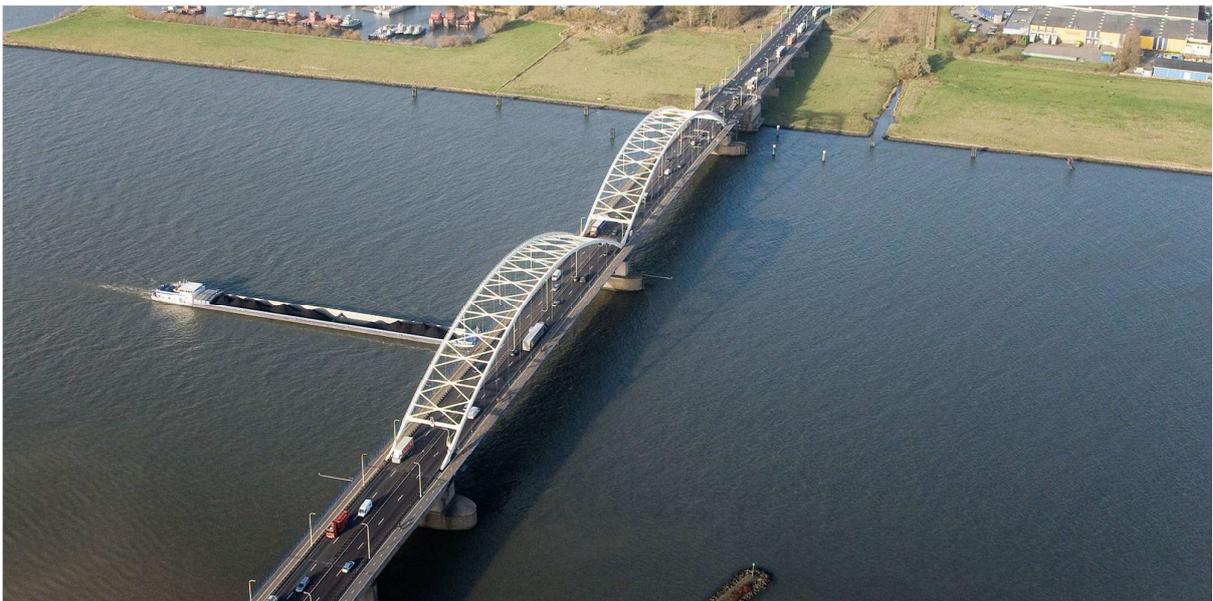
Figure 1. Merwede Bridge (source: [beeldbank.rws.nl](http://beeldbank.rws.nl))
