Slip coefficient of 90-year-old riveted joint surface with red lead paint for corrosion

Yu Chen, Takashi Yamaguchi

Graduate student & Professor, Osaka City University, Osaka, Japan

Motoshi Yamauchi, Keita Ueno

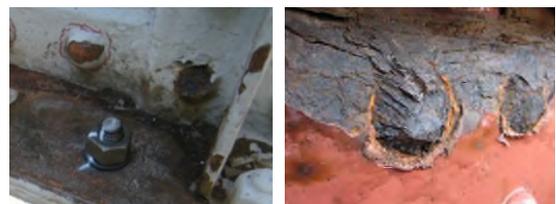
Figure 1. Rivet corrosion

elements' remaining bearing capacity [3][4]. For structural performance recovery or to extend their service life, the riveted bridges have to repair or reinforce by replacing the corroded rivets with high-strength bolts, e.g., Figure 1. Replacing the rivets with a high-strength bolt for changing to the frictional joint is a desirable approach to repairing the corroded riveted joint [5].
