Study on Evaluation Procedures for Prestressed Concrete Bridges Damaged by Salt Attack with Severe Corrosion of PC Cables

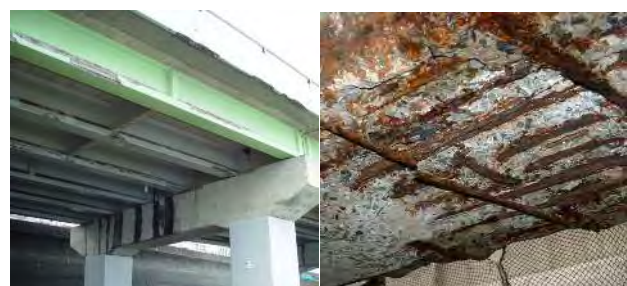
Photo 1. Severely deteriorated PC I-girder
due to salt attack

Photos 1 [a] and [b] show examples of deterioration to the stage that there is concern over potential

[a] PC I-girder
penetrated substantial
chloride ion

[b] PC I-girder with
corroded PC cables
due to salt attack
