## Structural rehabilitation and lengthening of three 50 year old locks in Limburg, the Netherlands

This paper provides an overview of the design and build project “Sluizen Limburg” project that was undertaken for Rijkswaterstaat. The paper includes a discussion on the solution to the overloading of the chamber-walls and the analysis and rehabilitation of the existing structures.

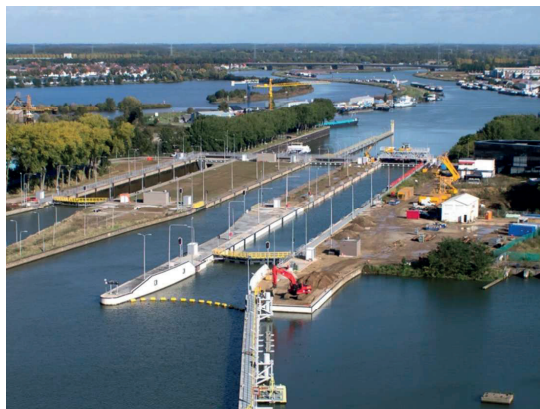
Figure 1: Lengthened lock at Maasbracht
