## Investigation of fastening failure in tram track structure on a bridge over the Vistula River

### Summary

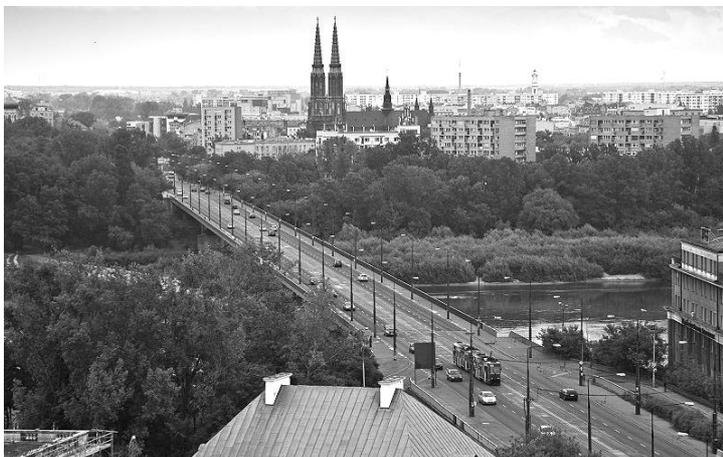
*Fig. 1: General view of the bridge*

The bridge was constructed in 1864 as the first permanent steel bridge over the Vistula river in Warsaw. The bridge received a new steel structure in 1949. A general view of the bridge is shown in Figure 1. In 2009, a refurbishment project for the W-Z route was conducted, which included replacement of the tramway track structure on the bridge. A slab track structure with embedded groove rails was introduced, and asphalt pavement laid on the tram lanes. The contract was a “design & build” project. The design for rebuilding the tram track structure on the bridge adapted a typical solution for railway track structures [1, 2]. A continuously embedded rail system (ERS)
