Investigations on a degraded suspension bridge: damage characterization and rehabilitation

This paper describes the experimental investigations and the planned rehabilitation programme of Teil Bridge in France. Soon after the sudden rupture of a cable near the anchorage, the bridge was closed to traffic. Inspections were carried out to understand the sources of this event and to assess the performance of cables and strand sockets. Prior to rehabilitation, the bridge safety was improved by strengthening each socket; the bridge was then re-opened to pedestrians and cyclists only. An acoustic emission system was installed during a full year period; events related to cable ruptures were accordingly monitored. Meanwhile, several other experimental investigations on steel and concrete materials (resilience, tensile steel strength, carbonation and chloride ingresses) were led to estimate the residual structural service life of the bridge and to plan repair actions. A major rehabilitation program was then scheduled with the change of all cables and sockets. This paper presents the different stages of these investigations and the rehabilitation process.

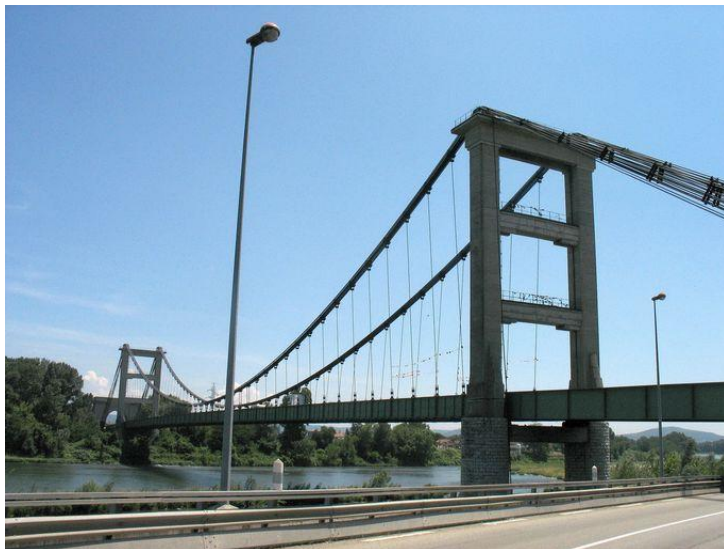
Fig. 1: The Teil bridge

The Teil bridge is a suspension bridge, built between 1947 and 1949; it carries the national road RN102 and crosses the Rhône river and the RD86 trunk road (Fig.1): it connects the Teil and Montélimar cities and 15,000 vehicles are using the bridge every day.
