Crossing of Bjørnafjorden – Floating Bridge Solution

Abstract

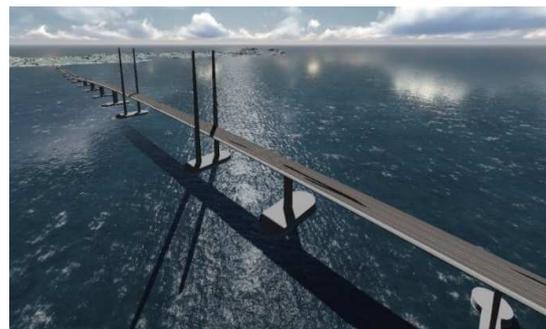
Fig. 1 Straight Bridge Alternative

The straight bridge alternative (see Fig. 1) consists of a unique steel girder resting on eighteen floating supports referred to as pontoons.

The bridge is assisted with mooring lines anchored to the seabed to withstand the large side loads acting on the structure due to the harsh wind, waves and current conditions expected in the fjord.
