Seismic Assessment and Retrofit of the Caronte Viaduct (A55 Highway, Martigues)

Denis Davi

Cerema - Territorial Division for the Mediterranean Regions, Aix-en-Provence, France

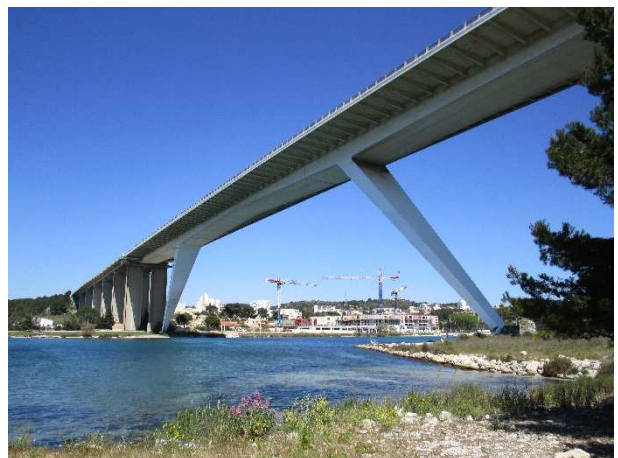
The Caronte emblematic viaduct of Martigues (Figure 1) enables the A55 Highway to cross the canal joining the Berre Bay and Mediterranean Sea in the South of France (Figure 2). It is composed of a main 300 meters steel strut frame bridge and four prestressed concrete access viaducts of about 300 meters each.

Figure 1. Caronte Viaduct general view
