How Reliable is our Building Process?

The paper presents the results of an investigation on collapsed roofs in the Netherlands after heavy snowfall in November 2005. Based on meteorological data and local observations and measurements the actual snow load which occurred is estimated and compared with statistical information. A comparison between the actual maximum snow loads and the snow load dictated in the code shows that both are of the same magnitude. The results of the investigations to the causes of collapse of 21 roofs are considered. In 14 cases design mistakes are assigned as (one of) the causes; also execution mistakes and lack of durability are assigned in several cases. In only 2 cases exceeding of the design load is assigned as (one of) the causes.

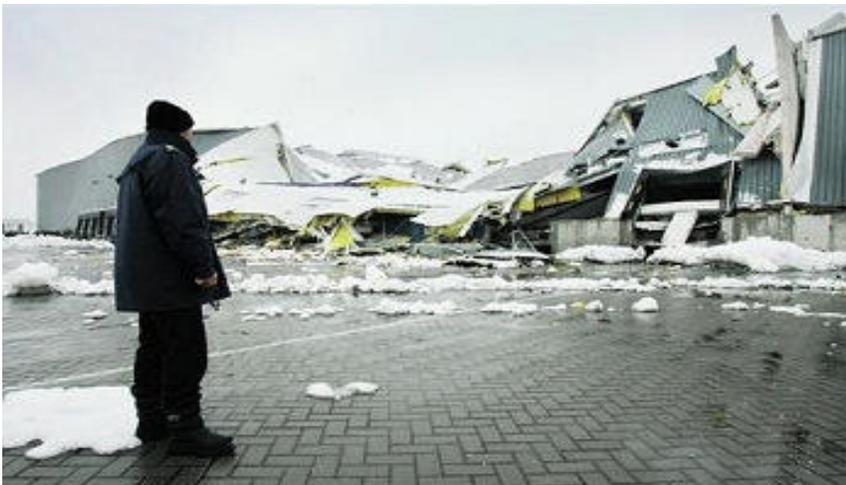
Fig. 1 *Industrial building collapsed due to snow load*
