IABSE Conference 2018 — Engineering the Past, to Meet the Needs of the Future June 25-27 2018, Copenhagen, Denmark

The Maintenance of Silver Jubilee Bridge, UK

Ray Langley, John Hehir and Ian Towler Mott MacDonald, Manchester, UK

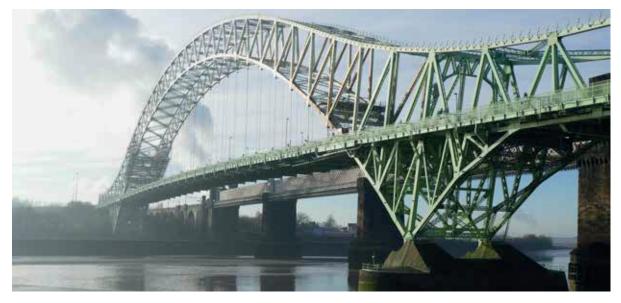
The Grade II listed Silver Jubilee Bridge is a two-pinned steel arch bridge with continuous side spans spanning the River Mersey. With a main span of 330 metres, it is the seventh largest steel arch bridge in the world. Since original construction in 1961, Mott MacDonald has been employed on numerous commissions and frameworks on the bridge providing technical and commercial advice to the maintainer, currently Halton Borough Council.

Figure 1. Elevation of the Silver Jubilee Bridge
