## Transformation of a 30 year old Oil Terminal into a modern double LNG Terminal – Part 2: Reconstruction of the New Berthing Line

The South Hook LNG Import Terminal is located at the former Esso refinery at Milford Haven, Wales. The original oil unloading jetty, built at the end of the 1950s, consisted of a 1km long approach trestle and a berthing head with five berths. The structure was closed in 1983 and was fully decommissioned in 1990. In 2003 it was decided to transform the Jetty into a modern LNG terminal by refurbishing the approach trestle and replacing the berthing line with two new state of the art berths and a control building platform.

This paper describes the reconstruction of the berthing line. As the upgraded structures were constructed in the location of the existing berths and approach ways, a range of practical problems were encountered. The first challenge to arise was the demolition of the existing trestles and berths, a process that required extensive planning and preparation. A second issue was the debris from the existing piles. Before demolition, a 3D laser scan was undertaken to determine the exact locations of numerous existing piles. All new structure

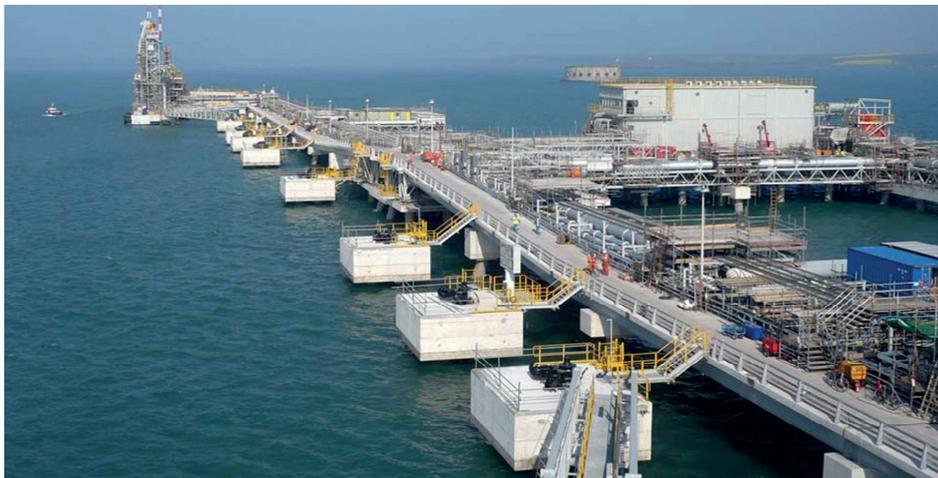
*Fig. 1: Jetty structural works completed*
